NSPS 0000a Annual Report

Oxy Permian Resources New Mexico Delaware Basin

Initial Reporting Period: 9/19/2015 – 8/2/2017

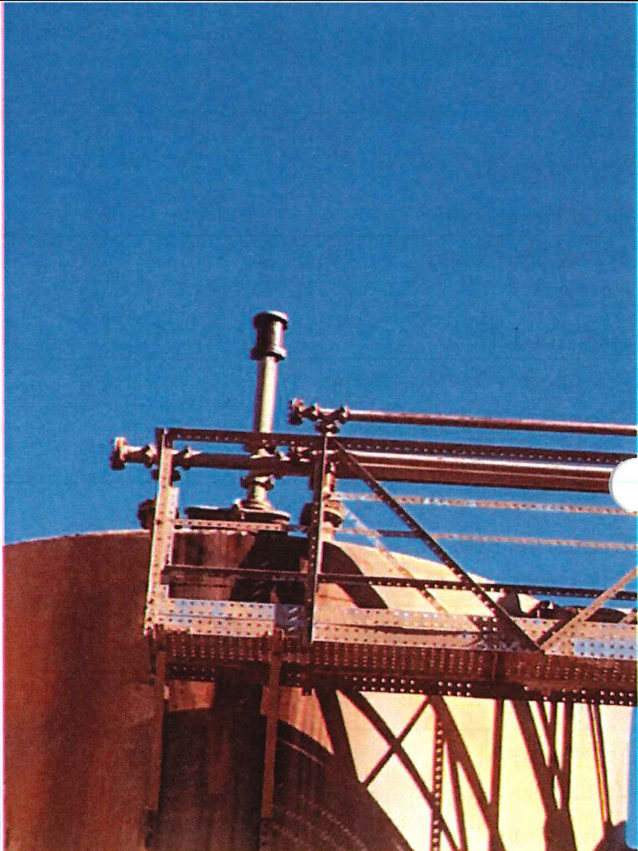
Type of Leaking Component?	Describe Leaking Component Location	Take iPhone photograph of leaking component and identify location.
Thief Hatch 60.5420a(b)(7)(vii) 60.5420a(b)(7)(viii)	West PW tank thief hatch S/N 1001-12 60.5420a(c)(15)(ii)(l)(8)

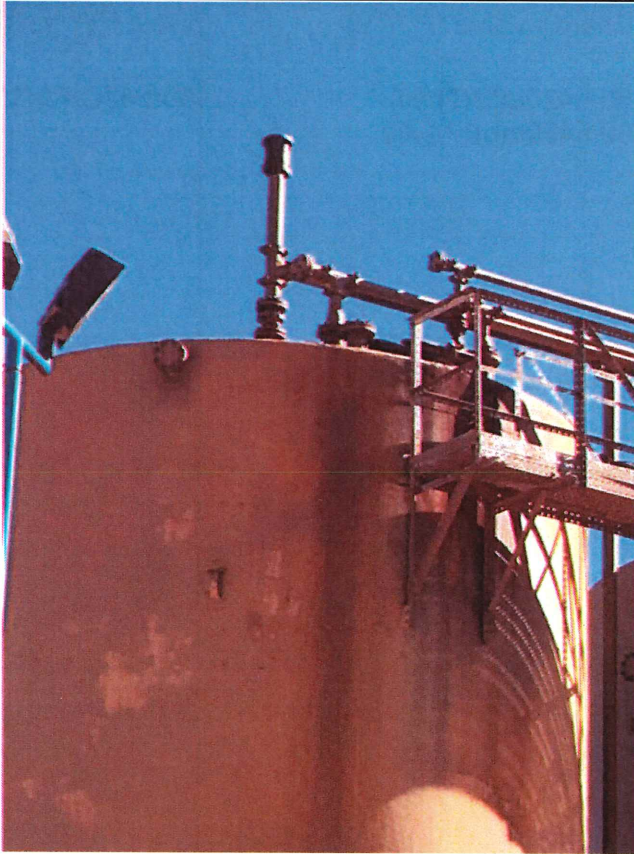
Type of Leaking Component?	Describe Leaking Component Location	Take iPhone photograph of leaking component and identify location.
Pressure Safety Valve (PSV) 60.5420a(b)(7)(vii) 60.5420a(b)(7)(viii)	West PW tank press relief hatch 60.5420a(c)(15)(ii)(l)(8)

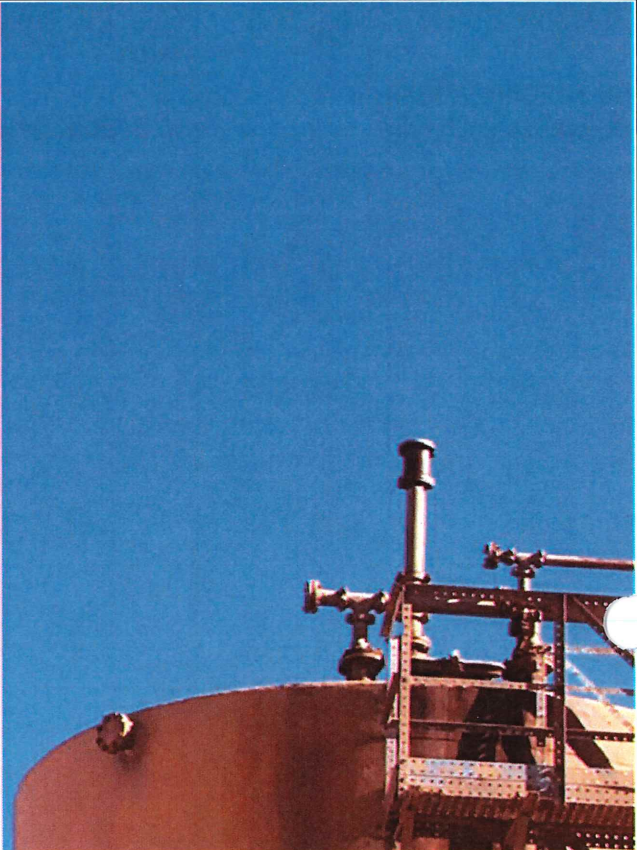
Type of Leaking Component?	Describe Leaking Component Location	Take iPhone photograph of leaking component and identify location.
Enardo Valve (PVRV) 60.5420a(b)(7)(vii) 60.5420a(b)(7)(viii)	West PW tank enardo 60.5420a(c)(15)(ii)(l)(8)

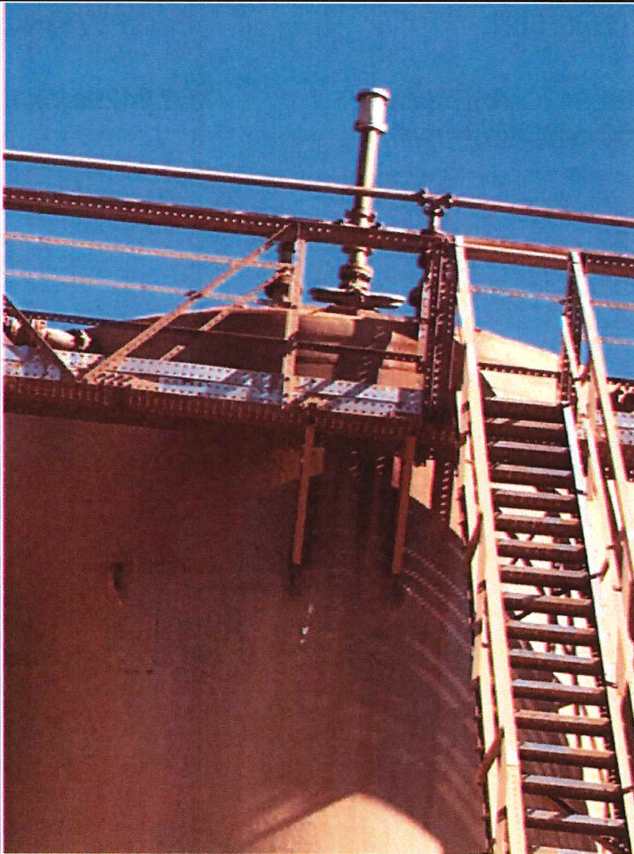
Type of Leaking Component?	Describe Leaking Component Location	Take iPhone photograph of leaking component and identify location.
Thief Hatch 60.5420a(b)(7)(vii) 60.5420a(b)(7)(viii)	Middle PW tank thief hatch 60.5420a(c)(15)(ii)(I)(8)

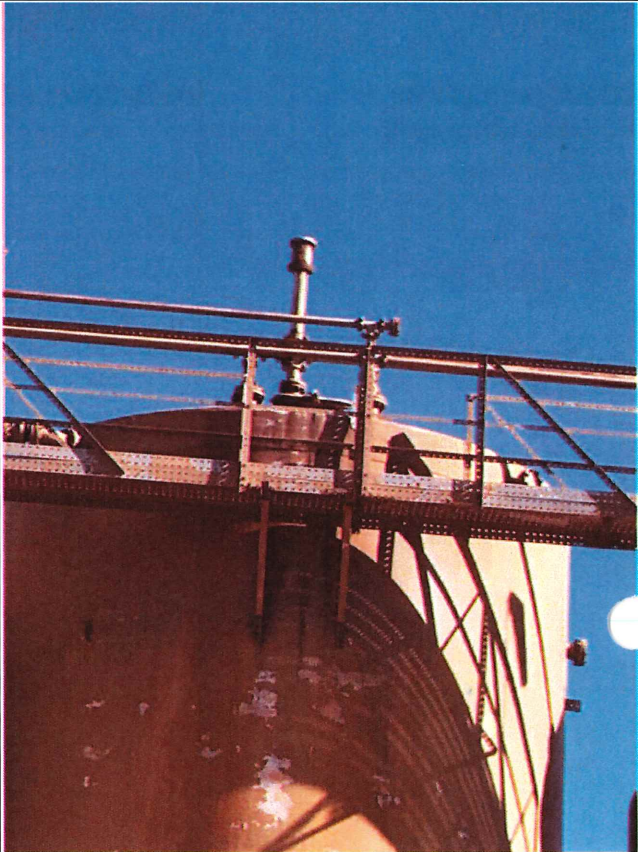
Type of Leaking Component?	Describe Leaking Component Location	Take iPhone photograph of leaking component and identify location.
Thief Hatch 60.5420a(b)(7)(vii) 60.5420a(b)(7)(viii)	East PW tank thief hatch 60.5420a(c)(15)(ii)(I)(8)

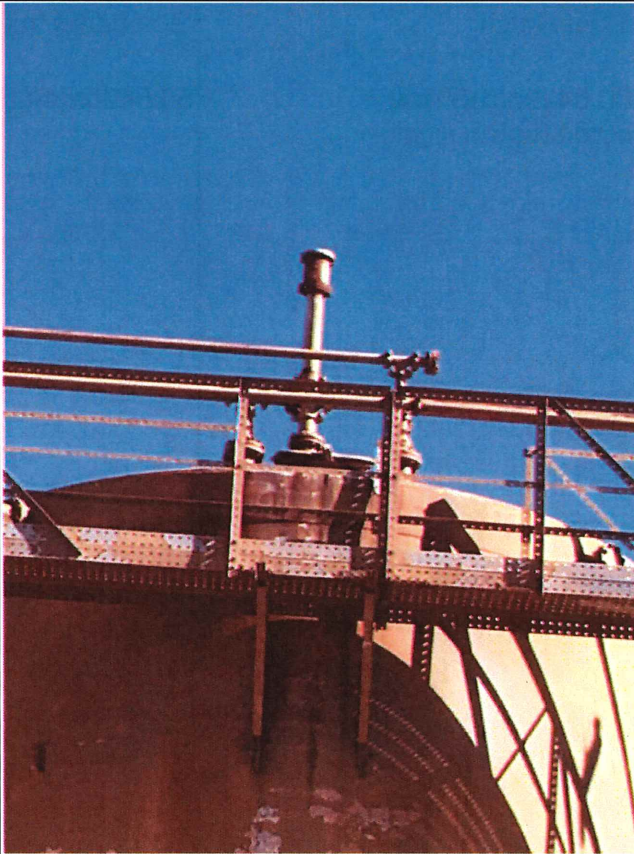
Type of Leaking Component?	Describe Leaking Component Location	Take iPhone photograph of leaking component and identify location.
Enardo Valve (PVRV) 60.5420a(b)(7)(vii) 60.5420a(b)(7)(viii)	East PW tank enardo 60.5420a(c)(15)(ii)(l)(8)

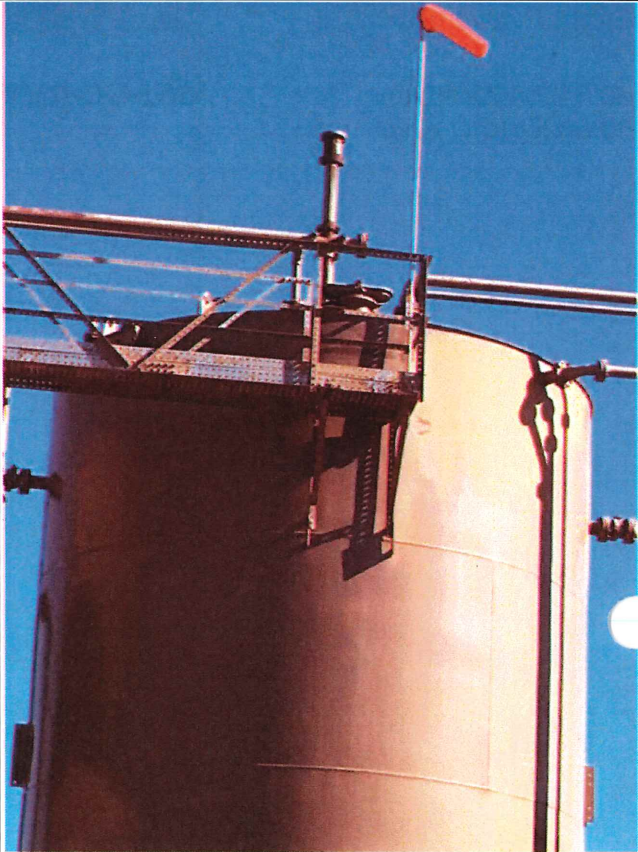
Type of Leaking Component?	Describe Leaking Component Location	Take iPhone photograph of leaking component and identify location.
Thief Hatch 60.5420a(b)(7)(vii) 60.5420a(b)(7)(viii)	Gun barrel thief hatch 60.5420a(c)(15)(ii)(I)(8)

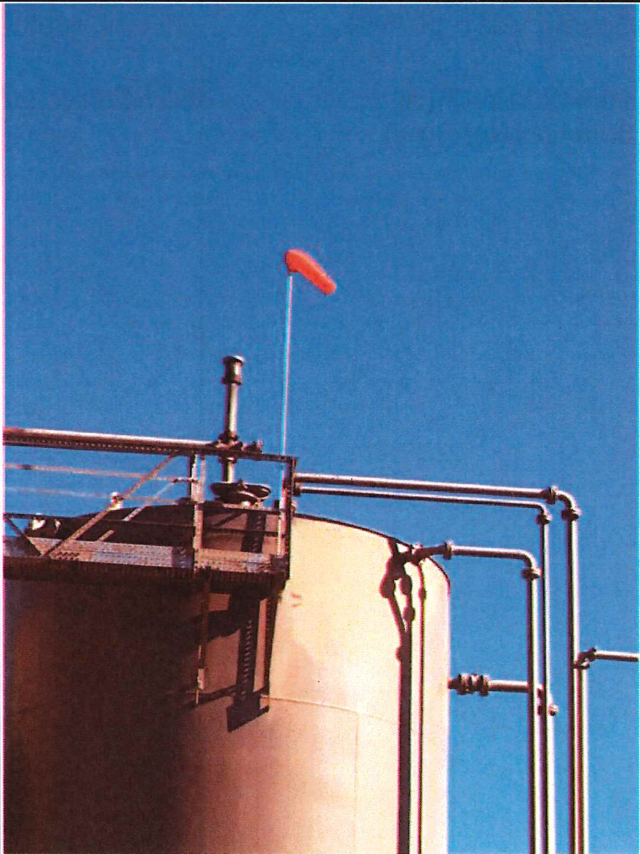
Type of Leaking Component?	Describe Leaking Component Location	Take iPhone photograph of leaking component and identify location.
Enardo Valve (PVRV) 60.5420a(b)(7)(vii) 60.5420a(b)(7)(viii)	Gun barrel enardo 60.5420a(c)(15)(ii)(l)(8)

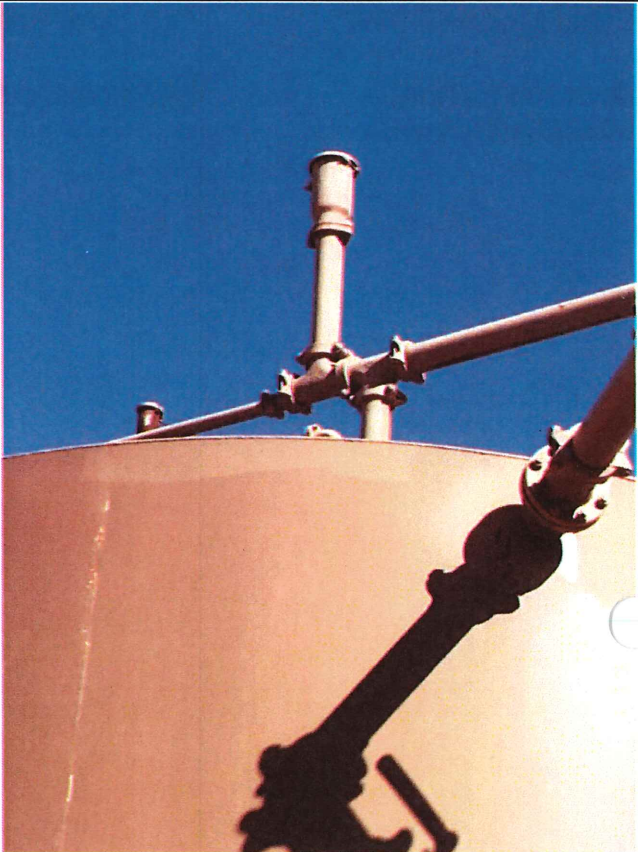
Type of Leaking Component?	Describe Leaking Component Location	Take iPhone photograph of leaking component and identify location.
Enardo Valve (PVRV) 60.5420a(b)(7)(vii) 60.5420a(b)(7)(viii)	Oil tank southwest enardo 60.5420a(c)(15)(ii)(l)(8)

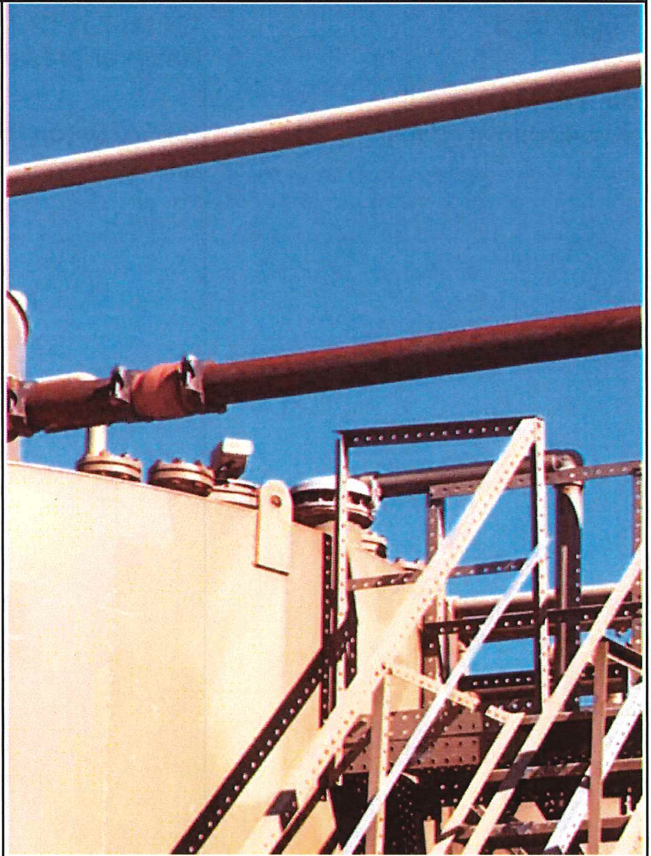
Type of Leaking Component?	Describe Leaking Component Location	Take iPhone photograph of leaking component and identify location.
Pressure Safety Valve (PSV) 60.5420a(b)(7)(vii) 60.5420a(b)(7)(viii)	Oil tank southwest pressure relief or thief hatch 60.5420a(c)(15)(ii)(I)(8)

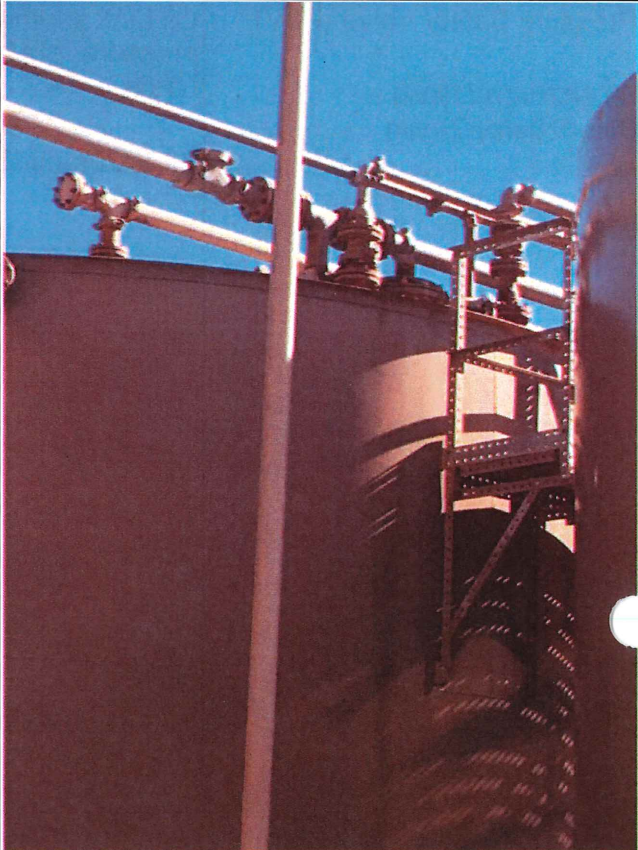
Type of Leaking Component?	Describe Leaking Component Location	Take iPhone photograph of leaking component and identify location.
Thief Hatch 60.5420a(b)(7)(vii) 60.5420a(b)(7)(viii)	Oil tank northwest thief hatch or pressure relief 60.5420a(c)(15)(ii)(I)(8)

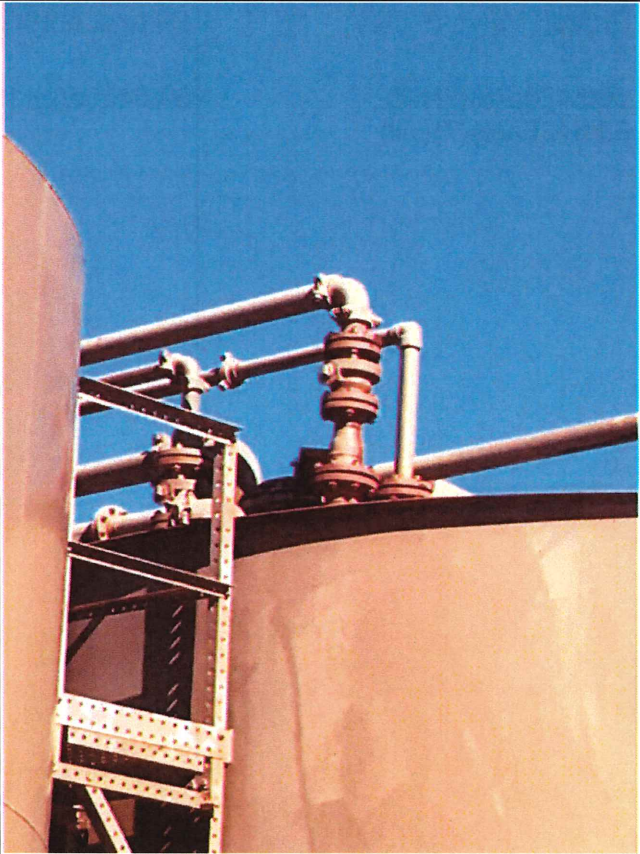
Type of Leaking Component?	Describe Leaking Component Location	Take iPhone photograph of leaking component and identify location.
Thief Hatch 60.5420a(b)(7)(vii) 60.5420a(b)(7)(viii)	Oil tank north east thief hatch or pressure relief valve 60.5420a(c)(15)(ii)(l)(8)

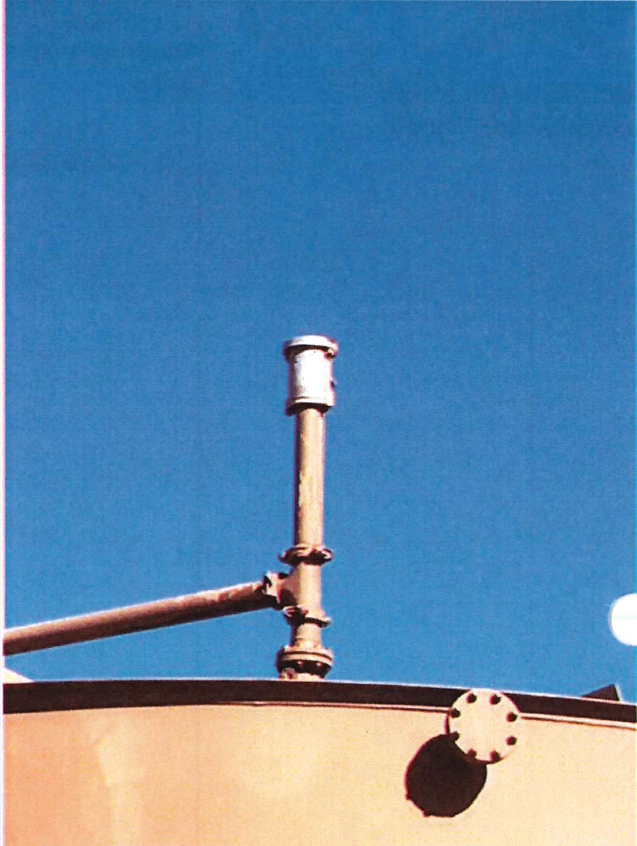
Type of Leaking Component?	Describe Leaking Component Location	Take iPhone photograph of leaking component and identify location.
Enardo Valve (PVRV) 60.5420a(b)(7)(vii) 60.5420a(b)(7)(viii)	Oil tank north east enardo 60.5420a(c)(15)(ii)(l)(8)

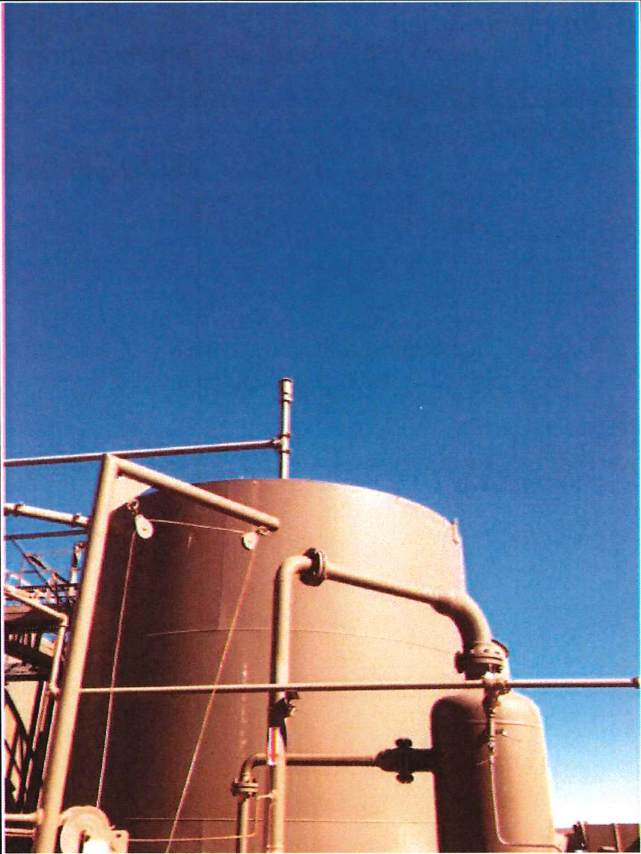
Type of Leaking Component?	Describe Leaking Component Location	Take iPhone photograph of leaking component and identify location.
Enardo Valve (PVRV) 60.5420a(b)(7)(vii) 60.5420a(b)(7)(viii)	Oil tank southeast enardo 60.5420a(c)(15)(ii)(l)(8)

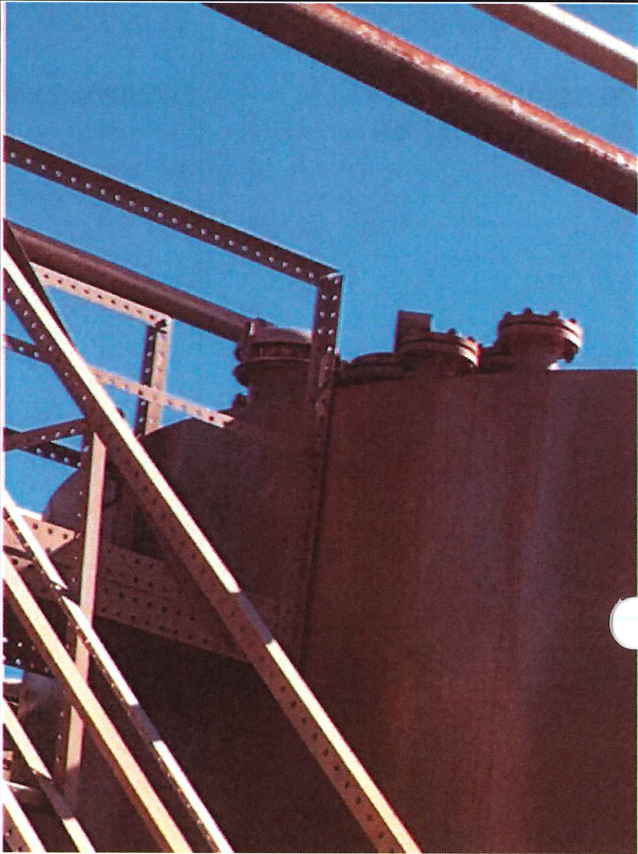
Type of Leaking Component?	Describe Leaking Component Location	Take iPhone photograph of leaking component and identify location.
Thief Hatch 60.5420a(b)(7)(vii) 60.5420a(b)(7)(viii)	Oil tank southeast thief hatch or pressure relief valve 60.5420a(c)(15)(ii)(l)(8)

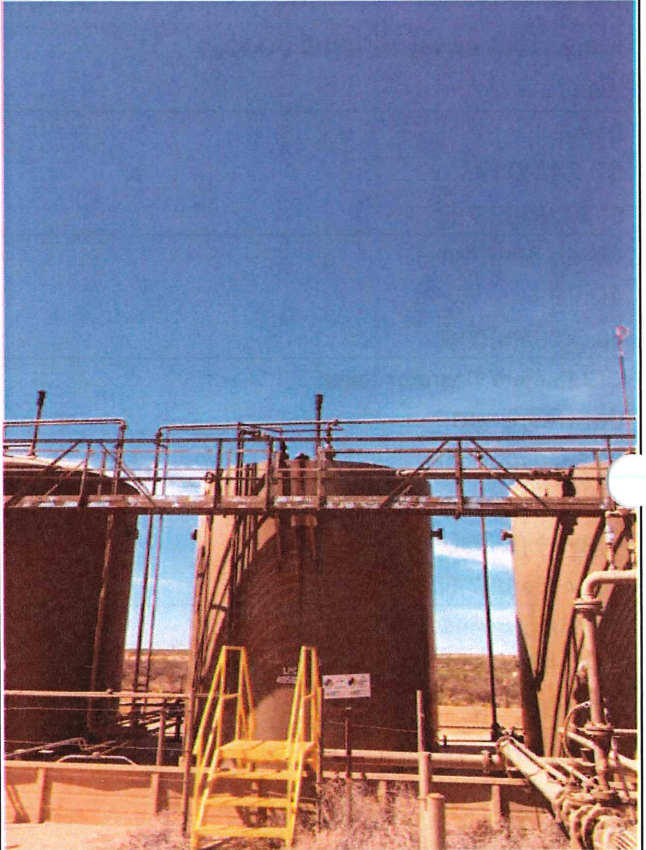
Type of Leaking Component?	Describe Leaking Component Location	Take iPhone photograph of leaking component and identify location.
Thief Hatch 60.5420a(b)(7)(vii) 60.5420a(b)(7)(viii)	Oil tank 1 thief hatch 60.5420a(c)(15)(ii)(l)(8)

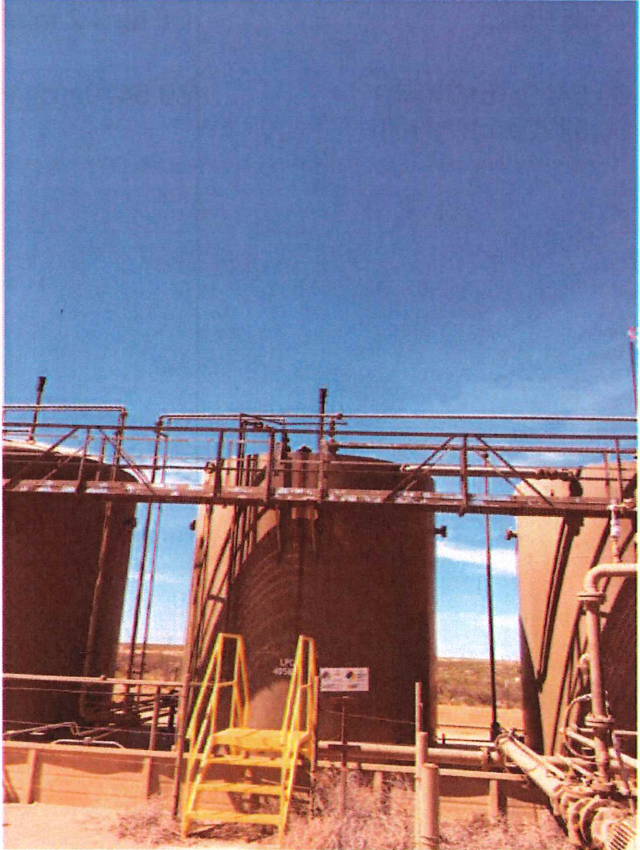
Type of Leaking Component?	Describe Leaking Component Location	Take iPhone photograph of leaking component and identify location.
Enardo Valve (PVRV) 60.5420a(b)(7)(vii) 60.5420a(b)(7)(viii)	Oil tank 1 common tank vent enardo 60.5420a(c)(15)(ii)(l)(8)

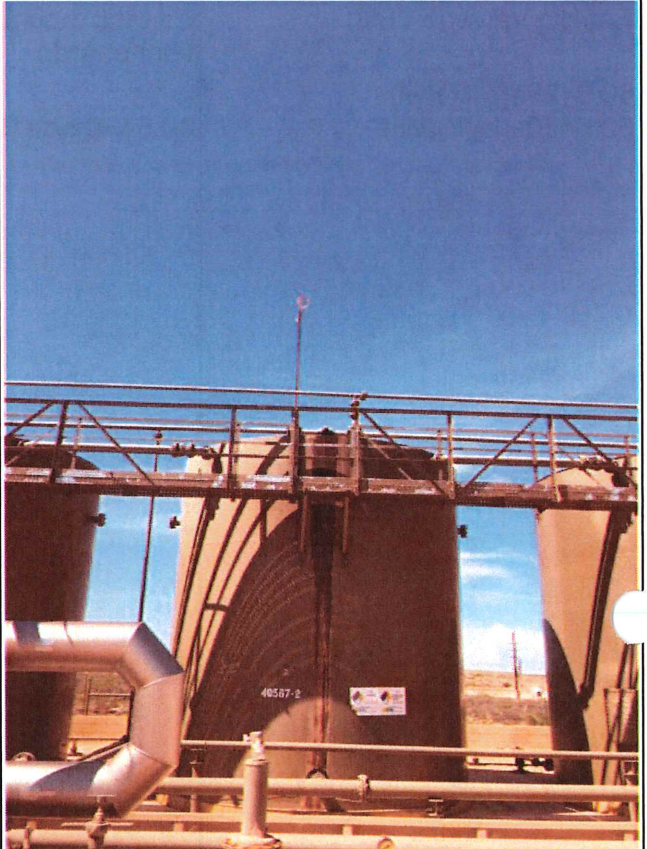
Type of Leaking Component?	Describe Leaking Component Location	Take iPhone photograph of leaking component and identify location.
Thief Hatch 60.5420a(b)(7)(vii) 60.5420a(b)(7)(viii)	Oil tank 2 thief hatch 60.5420a(c)(15)(ii)(l)(8)

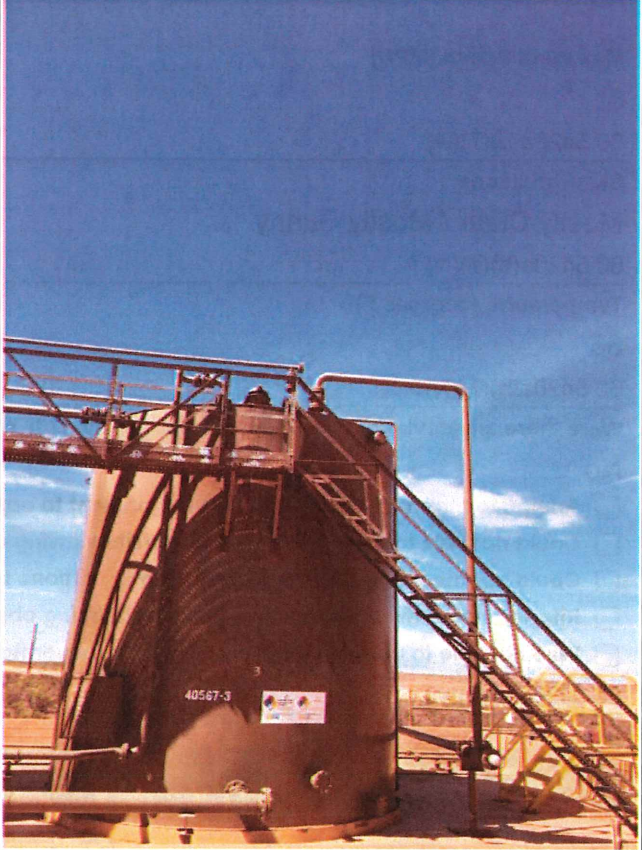
Type of Leaking Component?	Describe Leaking Component Location	Take iPhone photograph of leaking component and identify location.
Thief Hatch 60.5420a(b)(7)(vii) 60.5420a(b)(7)(viii)	Oil tank 3 thief hatch 60.5420a(c)(15)(ii)(l)(8)

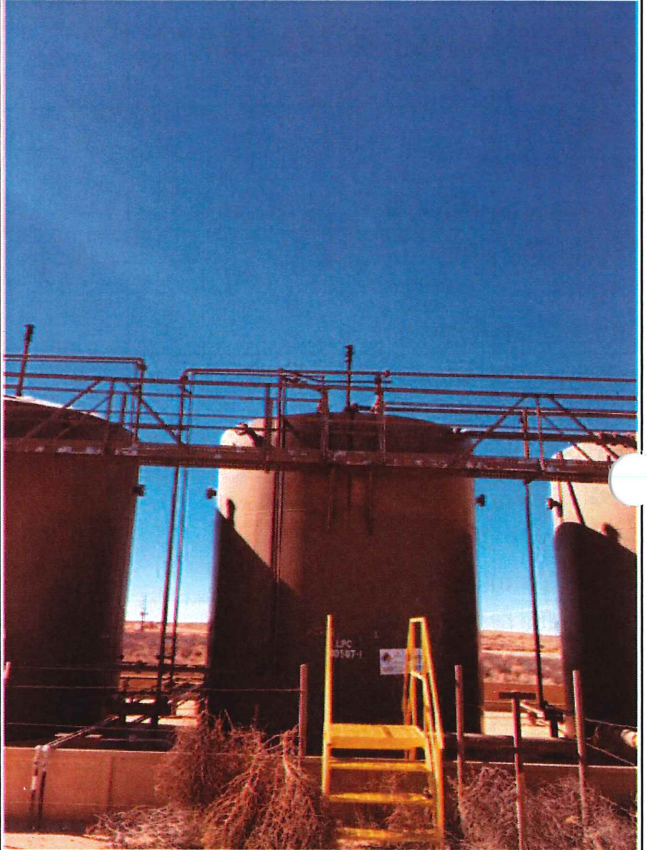
Type of Leaking Component?	Describe Leaking Component Location	Take iPhone photograph of leaking component and identify location.
Enardo Valve (PVRV) 60.5420a(b)(7)(vii) 60.5420a(b)(7)(viii)	Oil tank 1 common tank vent enardo pic 3710 60.5420a(c)(15)(ii)(l)(8)

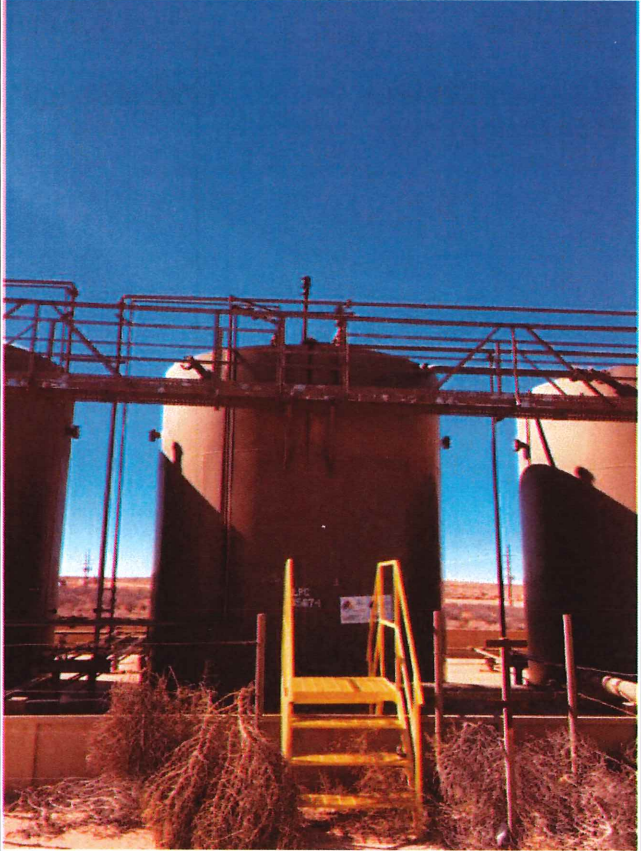
Type of Leaking Component?	Describe Leaking Component Location	Take iPhone photograph of leaking component and identify location.
Thief Hatch 60.5420a(b)(7)(vii) 60.5420a(b)(7)(viii)	Oil tank 1 thief hatch 60.5420a(c)(15)(ii)(l)(8)

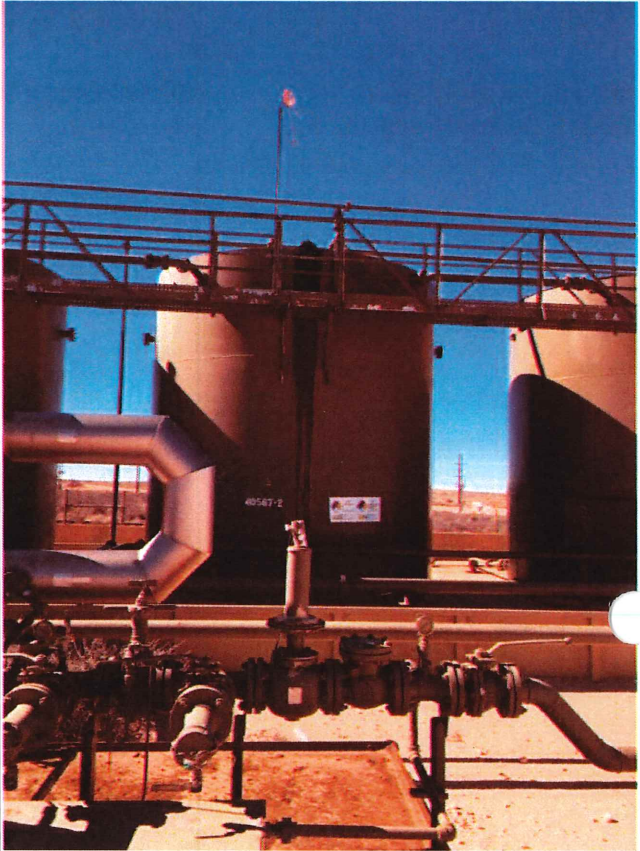
Type of Leaking Component?	Describe Leaking Component Location	Take iPhone photograph of leaking component and identify location.
Thief Hatch 60.5420a(b)(7)(vii) 60.5420a(b)(7)(viii)	Oil tank 2 thief hatch 60.5420a(c)(15)(ii)(l)(8)

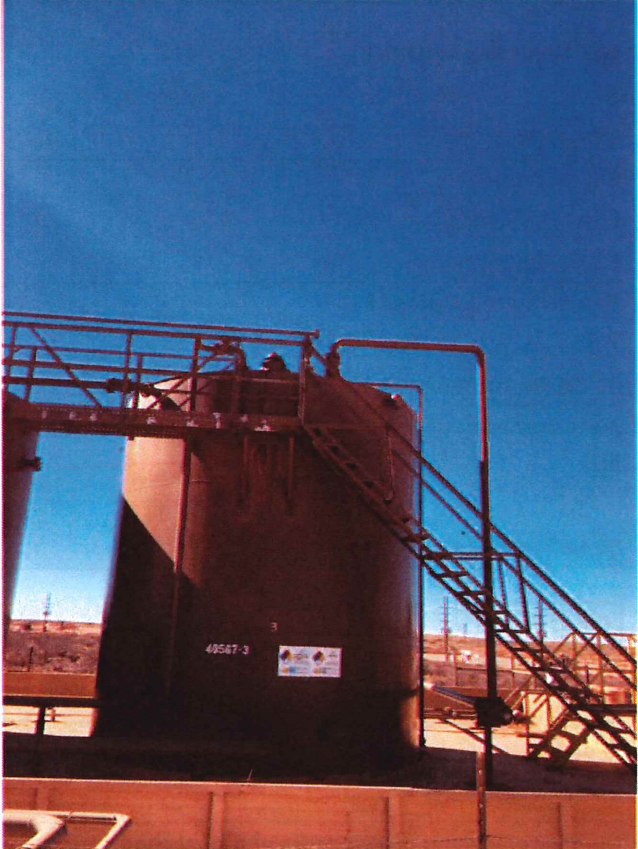
Type of Leaking Component?	Describe Leaking Component Location	Take iPhone photograph of leaking component and identify location.
Thief Hatch 60.5420a(b)(7)(vii) 60.5420a(b)(7)(viii)	Oil tank 3 thief hatch 60.5420a(c)(15)(ii)(l)(8)
